**Flood Control Project Maintenance
Levee Inspections**

Fall 2019 Levee Maintenance Deficiency Summary Report

Sacramento River Basin

Reclamation District No. 0070 Meridian

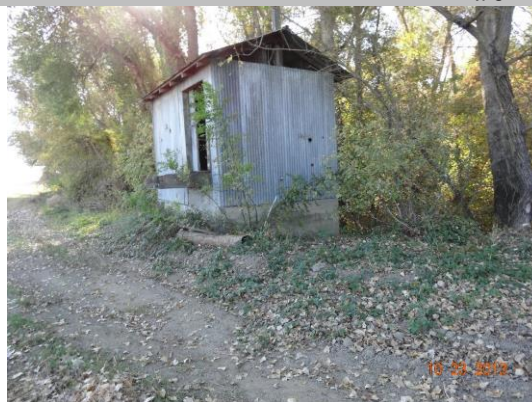
Photo 2 of 3 : UCIP_FA_2019_24190_42668.jpg

DS_ID:21388
FS_ID:24190
EP_NO: 10008
Repair Type: Non-Urgent
Crossing Status: Found
UCIP Comments: Concrete distribution box is damage on waterward side. Need to contact owner to determine status of crossing. If crossing is no longer in use owner will need to coordinate with DWR inspector and CVFPB to remove according to Title 23 requirements. This crossing is referenced in the USACE Periodic Inspection as item USACE_CESPK_MRD2_2012_p_0380.
FIELD_STRUCT_DESC: *ABANDONED* 18-inch steel irrigation discharge pipe through the levee, 15 feet below the crown. Pump in a pump house on the waterside (WS). Slide gate on the WS. Concrete distribution box on the landside (LS). During field verification, additional appurtenances were observed. An additional pipe on the LS drains into the concrete distribution box. The concrete distribution box connects to a second set of distribution boxes through a 24-inch reinforced concrete pipe approximately 36 feet upstream of the crossing. Those boxes have a 10-inch pipe which appears to go through the levee. (Retention of an 18-inch corrugated metal pipe (CMP) through the levee, 15 feet below the crown, a pump, a slide gate, and a concrete distribution box authorized under Automatic Board Order (ABO) issued as Permit No. 10008, 1974 - Frances C. Yates). [Additional Reference(s): DWR Levee Log, 2007. USACE Sacramento O&M Manual 134, June 1953, (Station 694+85)].

Pump house located on waterward side.

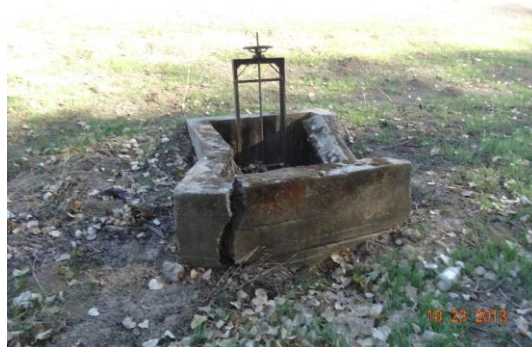
Photo 3 of 3 : UCIP_FA_2019_24190_42669.jpg

Comment Code						
Inspector Comment						
DS_ID:21388 FS_ID:24190 EP_NO: 10008 Repair Type: Non-Urgent Crossing Status: Found UCIP Comments: Concrete distribution box is damage on waterward side. Need to contact owner to determine status of crossing. If crossing is no longer in use owner will need to coordinate with DWR inspector and CVFPB to remove according to Title 23 requirements. This crossing is referenced in the USACE Periodic Inspection as item USACE_CESPK_MRD2_2012_p_0380. FIELD_STRUCT_DESC: *ABANDONED* 18-inch steel irrigation discharge pipe through the levee, 15 feet below the crown. Pump in a pump house on the waterside (WS). Slide gate on the WS. Concrete distribution box on the landside (LS). During field verification, additional appurtenances were observed. An additional pipe on the LS drains into the concrete distribution box. The concrete distribution box connects to a second set of distribution boxes through a 24-inch reinforced concrete pipe approximately 36 feet upstream of the crossing. Those boxes have a 10-inch pipe which appears to go through the levee. (Retention of an 18-inch corrugated metal pipe (CMP) through the levee, 15 feet below the crown, a pump, a slide gate, and a concrete distribution box authorized under Automatic Board Order (ABO) issued as Permit No. 10008, 1974 - Frances C. Yates). [Additional Reference(s): DWR Levee Log, 2007. USACE Sacramento O&M Manual 134, June 1953, (Station 694+85)]. FS Date: 10/23/2013

Damage concrete distribution box located on waterward side.

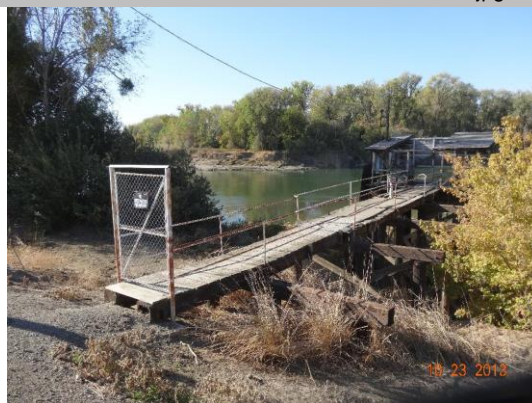
Photo 1 of 3 : UCIP_FA_2019_24108_42463.jpg

Comment Code						
Inspector Comment						
DS_ID:21423 FS_ID:24108 EP_NO: 9971 Repair Type: Non-Urgent Crossing Status: Found UCIP Comments: Will need to contact owner. Need to obtain maintenance records and clarify modifications made to crossing (size). This crossing is referenced in the USACE Periodic Inspection as item USACE_CESPK_MRD2_2012_p_0433. FIELD_STRUCT_DESC: [Meridian Farms Water Company Pumping Plant No. 3] 2 of 3: 16-inch irrigation discharge pipe of an unknown material (not a 30-inch pipe, as mentioned in the desk study) through the levee, 20.5 feet below the crown. Gate valve on the waterside (WS) end. Pump on a pile structure in the stream. Wooden walkway to the pump. Concrete distribution box on the landside (LS). (Retention of a 30-inch steel pipe through the levee, 20.5 feet below the crown, a pump, a gate valve, and a concrete distribution box authorized under Automatic Board Order (ABO) issued as Permit No. 9971, 1974 - Georgia Chesney, Life Estate. Plans to demolish and remove the existing Meridian Diversion Pumping Facility and the existing Drexler Diversion Pumping Facility and to construct a new Meridian Diversion Pumping Facility with two retractable fish screens and a 72-inch gravity feed intake pipe under the levee authorized under Permit No. 18762, 2013 - Meridian Farms Water Company). [Additional Reference(s): DWR Levee Log, 2007]. FS Date: 10/23/2013

View of landward side--pump station and walkway

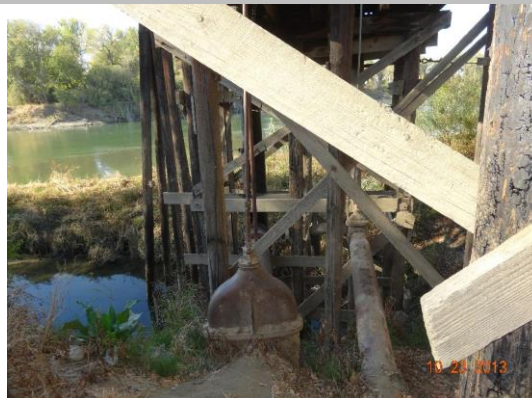
Photo 2 of 3 : UCIP_FA_2019_24108_42465.jpg

Comment Code						
Inspector Comment						
DS_ID:21423 FS_ID:24108 EP_NO: 9971 Repair Type: Non-Urgent Crossing Status: Found UCIP Comments: Will need to contact owner. Need to obtain maintenance records and clarify modifications made to crossing (size). This crossing is referenced in the USACE Periodic Inspection as item USACE_CESPK_MRD2_2012_p_0433. FIELD_STRUCT_DESC: [Meridian Farms Water Company Pumping Plant No. 3] 2 of 3: 16-inch irrigation discharge pipe of an unknown material (not a 30-inch pipe, as mentioned in the desk study) through the levee, 20.5 feet below the crown. Gate valve on the waterside (WS) end. Pump on a pile structure in the stream. Wooden walkway to the pump. Concrete distribution box on the landside (LS). (Retention of a 30-inch steel pipe through the levee, 20.5 feet below the crown, a pump, a gate valve, and a concrete distribution box authorized under Automatic Board Order (ABO) issued as Permit No. 9971, 1974 - Georgia Chesney, Life Estate. Plans to demolish and remove the existing Meridian Diversion Pumping Facility and the existing Drexler Diversion Pumping Facility and to construct a new Meridian Diversion Pumping Facility with two retractable fish screens and a 72-inch gravity feed intake pipe under the levee authorized under Permit No. 18762, 2013 - Meridian Farms Water Company). [Additional Reference(s): DWR Levee Log, 2007]. FS Date: 10/23/2013

View of 16-inch pipe and 24-inch pipe with screw gate located on waterward side.

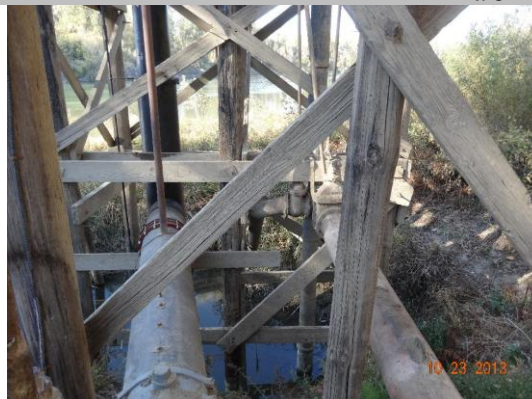
Photo 3 of 3 : UCIP_FA_2019_24108_42464.jpg

View of 16-inch pipe and 24-inch pipe located on waterward side.

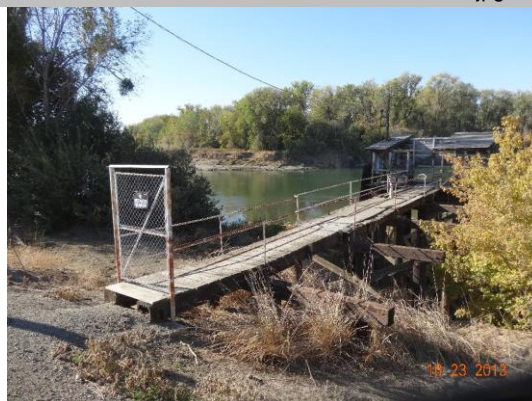
Photo 1 of 3 : UCIP_FA_2019_24107_42457.jpg

Comment Code					
Inspector Comment					
DS_ID:21394 FS_ID:24107 EP_NO: N/A Repair Type: Non-Urgent Crossing Status: Found UCIP Comments: This pump station is to be demolished. This crossing will need to be updated once the work has been completed. This crossing is referenced in the USACE Periodic Inspection as item USACE_CESPK_MRD2_2012_p_0433. FIELD_STRUCT_DESC: [Meridian Farms Water Company Pumping Plant No. 3] 3 of 3: 24-inch irrigation discharge pipe of an unknown material through the levee, 20.5 feet below the crown. Gate valve on the waterside (WS) end. Pump on a pile structure in the stream. Wooden walkway to the pump. Concrete distribution box on the landside (LS). (Plans to demolish and remove the existing Meridian Diversion Pumping Facility and the existing Drexler Diversion Pumping Facility and to construct a new Meridian Diversion Pumping Facility with two retractable fish screens and a 72-inch gravity feed intake pipe under the levee authorized under Permit No. 18762, 2013 - Meridian Farms Water Company). [Additional Reference(s): DWR Levee Log, 2007]. FS Date: 10/23/2013

View of waterward side--pump station and walkway.

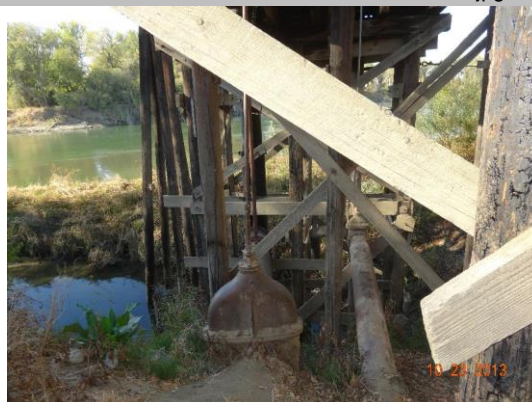
Photo 2 of 3 : UCIP_FA_2019_24107_42458.jpg

View of 16-inch pipe and 24-inch pipe through levee on waterward side.

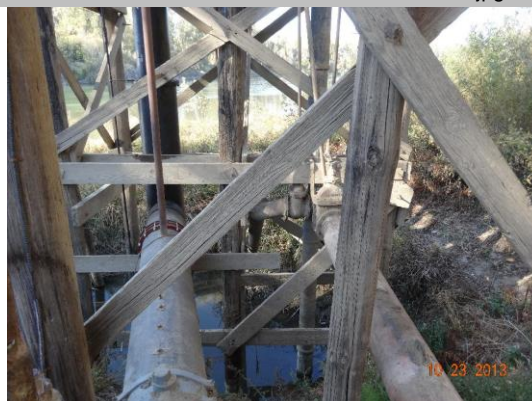
Photo 3 of 3 : UCIP_FA_2019_24107_42461.jpg

Comment Code					
Inspector Comment					
DS_ID:21394 FS_ID:24107 EP_NO: N/A Repair Type: Non-Urgent Crossing Status: Found UCIP Comments: This pump station is to be demolished. This crossing will need to be updated once the work has been completed. This crossing is referenced in the USACE Periodic Inspection as item USACE_CESPK_MRD2_2012_p_0433. FIELD_STRUCT_DESC: [Meridian Farms Water Company Pumping Plant No. 3] 3 of 3: 24-inch irrigation discharge pipe of an unknown material through the levee, 20.5 feet below the crown. Gate valve on the waterside (WS) end. Pump on a pile structure in the stream. Wooden walkway to the pump. Concrete distribution box on the landside (LS). (Plans to demolish and remove the existing Meridian Diversion Pumping Facility and the existing Drexler Diversion Pumping Facility and to construct a new Meridian Diversion Pumping Facility with two retractable fish screens and a 72-inch gravity feed intake pipe under the levee authorized under Permit No. 18762, 2013 - Meridian Farms Water Company). [Additional Reference(s): DWR Levee Log, 2007]. FS Date: 10/23/2013

View of pipes located on waterward side.

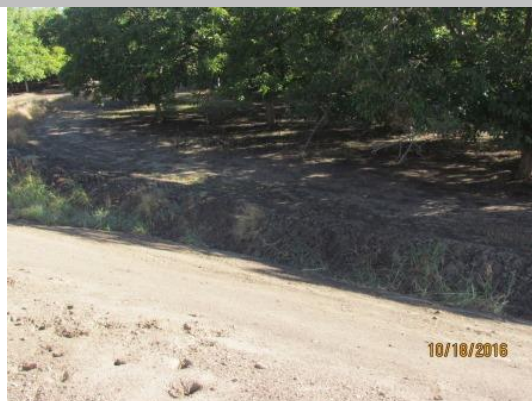
Photo 1 of 1 : FA_2019_RD0070_30_62_20190822_00010.jpg

LM Start	9.57	Rating **	M	Issue No.	62							
LM End	9.70	Issue Type +	En	Location *	LS							
Category	Earthen Levee		GPS Latitude/Longitude									
			Start	End								
Item	Encroachments		39.103192°	39.101213°								
			-121.899606°	-121.899380°								
DWR ID	DWR_RD0070_02_f_2016_62											
Comment Code												
DT : Ditch												
Inspector Comment

View of a ditch along the landside toe.

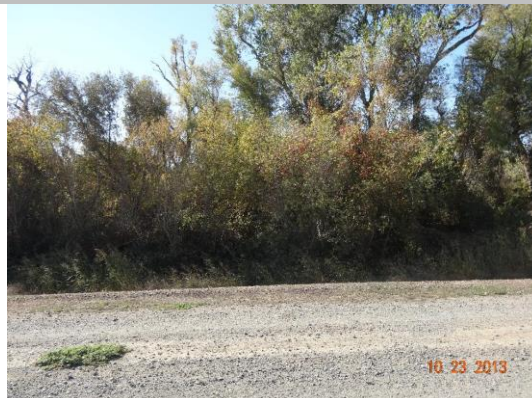
Photo 1 of 3 : UCIP_FA_2019_23967_42129.jpg

Comment Code					
Inspector Comment					
DS_ID:21396 FS_ID:23967 EP_NO: N/A Repair Type: Non-Urgent Crossing Status: Indicator Found UCIP Comments: No evidence of pipe is visible on waterward side. Need to coordinate with owner to determine status of crossing. If crossing is no longer in use owner will need to contact the CVFPB to comply with Title 23. This crossing is referenced in the USACE Periodic Inspection as item USACE_CESPK_MRD2_2012_p_0477. FIELD_STRUCT_DESC: *ABANDONED* 12-inch pipe of an unknown material or purpose through the levee, 3.1 feet below the crown. Siphon breaker in a corrugated metal pipe (CMP) riser on the landside (LS) shoulder. Concrete plug on the LS end. Wooden distribution box on the LS at the discharge end. (Cat. IV-A). [Additional Reference(s): DWR Levee Log, 2007. USACE Sacramento O&M Manual 134, June 1953, (Station 813+00)]. FS Date: 10/23/2013

View of waterward side.

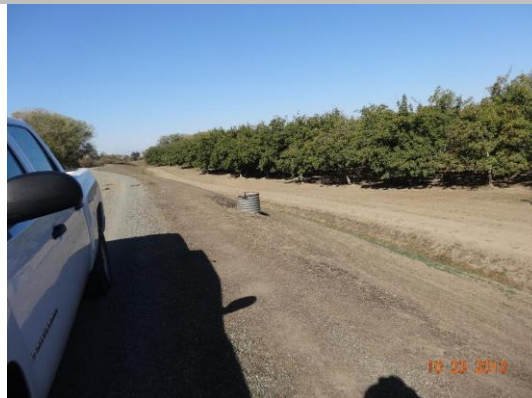
Photo 3 of 3 : UCIP_FA_2019_23967_42131.jpg

Comment Code					
Inspector Comment					
DS_ID:21396 FS_ID:23967 EP_NO: N/A Repair Type: Non-Urgent Crossing Status: Indicator Found UCIP Comments: No evidence of pipe is visible on waterward side. Need to coordinate with owner to determine status of crossing. If crossing is no longer in use owner will need to contact the CVFPB to comply with Title 23. This crossing is referenced in the USACE Periodic Inspection as item USACE_CESPK_MRD2_2012_p_0477. FIELD_STRUCT_DESC: *ABANDONED* 12-inch pipe of an unknown material or purpose through the levee, 3.1 feet below the crown. Siphon breaker in a corrugated metal pipe (CMP) riser on the landside (LS) shoulder. Concrete plug on the LS end. Wooden distribution box on the LS at the discharge end. (Cat. IV-A). [Additional Reference(s): DWR Levee Log, 2007. USACE Sacramento O&M Manual 134, June 1953, (Station 813+00)]. FS Date: 10/23/2013

CMP riser located on landward shoulder.

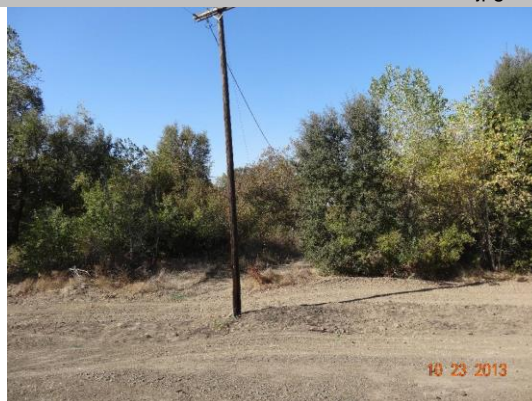
Photo 1 of 3 : UCIP_FA_2019_24195_42686.jpg

Comment Code					
Inspector Comment					
DS_ID:21398 FS_ID:24195 EP_NO: 1162 Repair Type: Non-Urgent Crossing Status: Found UCIP Comments: Need to verify status of crossing--variation in pipe size. 18 inch pipe listed in desk study and 20 inch pipe found in field. Damage to siphon breaker housing unit. This crossing is referenced in the USACE Periodic Inspection as item USACE_CESPK_MRD2_2012_p_0482. FIELD_STRUCT_DESC: 1 of 2: 20-inch steel irrigation discharge pipe (not 18-inch, as referenced in the permit) through the levee, 3.7 feet below the crown. Concrete cutoff wall around the pipe at each shoulder. Siphon breaker in a steel pipe riser on the landside (LS) shoulder. Slant pump on a wooden pump structure on the waterside (WS). Corrugated metal pipe (CMP) riser under the pump structure at the WS toe. Distribution box at the LS toe. (Plans for the installation of two 18-inch steel discharge pipes through the levee and a pumping plant in the river authorized under Permit No. 1162, 1946 - Homer and Arthur Andreotti). [Additional Reference(s): DWR Levee Log, 2007. USACE Sacramento O&M Manual 134, June 1953, (Station 824+00)]. FS Date: 10/23/2013

View of waterward side pathway behind power pole leads to pump station.

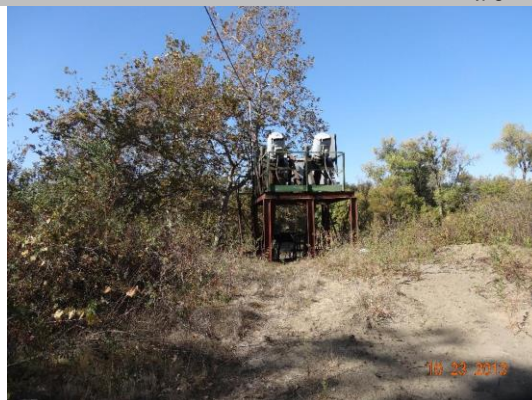
Photo 2 of 3 : UCIP_FA_2019_24195_42685.jpg

Pump station located on waterward side.

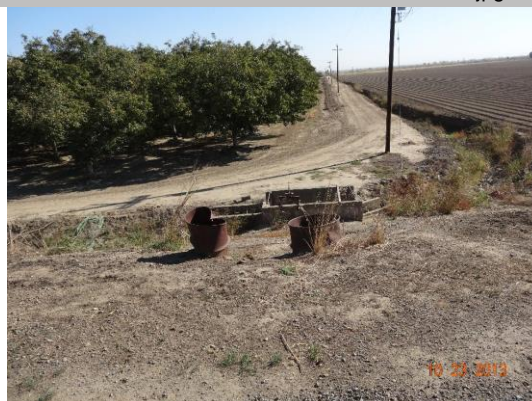
Photo 3 of 3 : UCIP_FA_2019_24195_42688.jpg

Item	DRAFT DWR UCIP Field Study			39.093712 °	39.093712 °	
				-121.892553 °	-121.892553 °	
DWR ID	21398					
Comment Code						
Inspector Comment						
DS_ID:21398 FS_ID:24195 EP_NO: 1162 Repair Type: Non-Urgent Crossing Status: Found UCIP Comments: Need to verify status of crossing--variation in pipe size. 18 inch pipe listed in desk study and 20 inch pipe found in field. Damage to siphon breaker housing unit. This crossing is referenced in the USACE Periodic Inspection as item USACE_CESPK_MRD2_2012_p_0482. FIELD_STRUCT_DESC: 1 of 2: 20-inch steel irrigation discharge pipe (not 18-inch, as referenced in the permit) through the levee, 3.7 feet below the crown. Concrete cutoff wall around the pipe at each shoulder. Siphon breaker in a steel pipe riser on the landside (LS) shoulder. Slant pump on a wooden pump structure on the waterside (WS). Corrugated metal pipe (CMP) riser under the pump structure at the WS toe. Distribution box at the LS toe. (Plans for the installation of two 18-inch steel discharge pipes through the levee and a pumping plant in the river authorized under Permit No. 1162, 1946 - Homer and Arthur Andreotti). [Additional Reference(s): DWR Levee Log, 2007. USACE Sacramento O&M Manual 134, June 1953, (Station 824+00)]. FS Date: 10/23/2013

View of landward side.

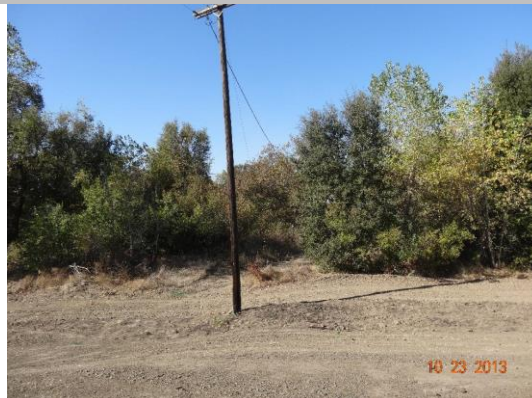
Photo 1 of 3 : UCIP_FA_2019_24196_42693.jpg

DS_ID:21430
FS_ID:24196
EP_NO: 1162
Repair Type: Non-Urgent
Crossing Status: Found
UCIP Comments: Need to verify status of crossing--variation in pipe size. 18 inch pipe listed in desk study and 20 inch pipe found in field. This crossing is referenced in the USACE Periodic Inspection as item USACE_CESPK_MRD2_2012_p_0482.
FIELD_STRUCT_DESC: 2 of 2: 20-inch steel irrigation discharge pipe (not 18-inch, as referenced in the permit) through the levee, 3.7 feet below the crown. Concrete cutoff wall around the pipe at each shoulder. Siphon breaker in a steel pipe riser on the landside (LS) shoulder. Slant pump on a wooden pump structure on the waterside (WS). Corrugated metal pipe (CMP) riser under the pump structure at the WS toe. Distribution box at the LS toe. (Plans for the installation of two 18-inch steel discharge pipes through the levee and a pumping plant in the river authorized under Permit No. 1162, 1946 - Homer and Arthur Andreotti). [Additional Reference(s): DWR Levee Log, 2007. USACE Sacramento O&M Manual 134, June 1953, (Station 824+00)].

View of waterward side path to pump station is behind the power pole.

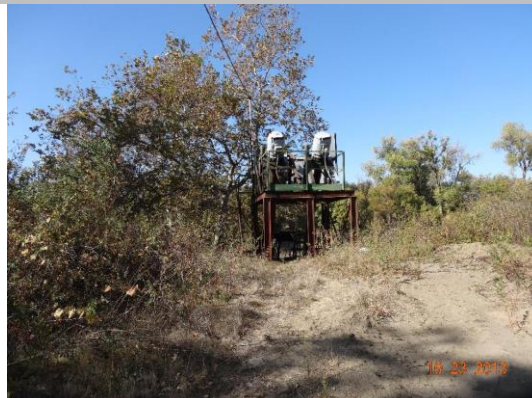
Photo 2 of 3 : UCIP_FA_2019_24196_42692.jpg

Pump station on waterward side dense vegetation on slope.

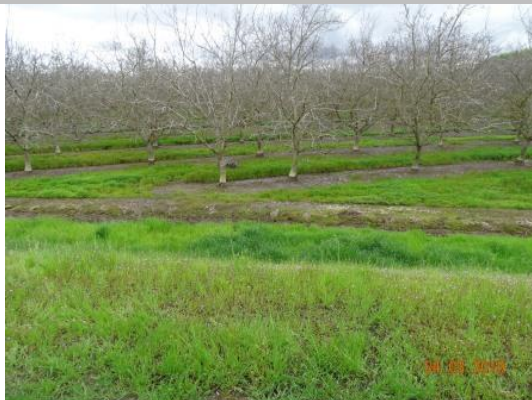
Photo 2 of 2 : FA_2019_RD0070_30_77_20190822_00019.jpg

LM Start	10.76	Rating **	A	Issue No.	77 (cont)	
LM End	10.76	Issue Type +	Ob	Location *	LS	
Category	Earthen Levee			GPS Latitude/Longitude		
				Start	End	
Item	Seepage / Sandboils			39.088646 °	39.088646 °	
				-121.893987 °	-121.893987 °	
DWR ID	DWR_RD0070_02_s_2019_77					
Comment Code						
Inspector Comment						
RD placed a stake to mark the location of a boil. RD mentioned that the boil is within the ditch. Boil should be monitored during high water.

View of the ditch on the landside and outside of the levee easement.

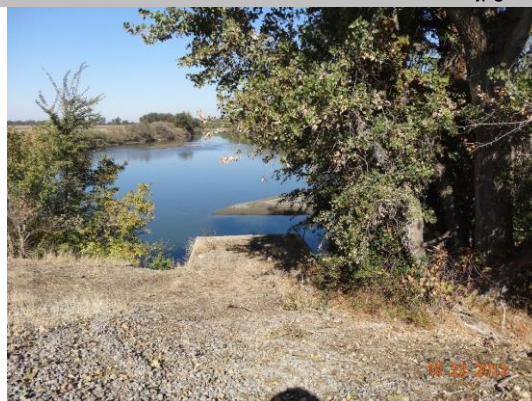
Photo 1 of 3 : UCIP_FA_2019_24197_42699.jpg

DS_ID:21400
FS_ID:24197
EP_NO: 9986
Repair Type: Non-Urgent
Crossing Status: Indicator Found
UCIP Comments: Need to coordinate with owner to determine status of crossing. If crossing is no longer in use owner will need to contact the CVFPB to comply with Title 23. This crossing is referenced in the USACE Periodic Inspection as item USACE_CESPK_MRD2_2012_p_0527.
FIELD_STRUCT_DESC: *ABANDONED* 30-inch steel irrigation discharge pipe through the levee, 27.5 feet below the crown. Two electric gate valves in a concrete pit on the waterside (WS) end, at the end of the discharge pipe. Two slant pumps on the WS slope. Control switches in a corrugated metal shed at the WS shoulder. (Plans for the installation of two inclined turbine pumps, a gate valve, a 50-horsepower pump, and an electrical conduit authorized under Permit No. 5193, 1965 - Meridian Farms Water Company. Retention of a 30-inch steel pipe through the levee, 27.5 feet below the crown, two gate valves, two slant pumps, and a metal building with switch panels authorized under Automatic Board Order (ABO) issued as Permit No. 9986, 1974 - Meridian Farms Water Company. Plans to abolish existing pumping plant and to abandon existing pipeline at RM 125.8 and to construct a new pumping plant at RM 127.0 consisting of two 30-inch intake pipes supported by seven 10-inch by 10-inch H beams, a fish screen, and a 36-inch pipe trenched through the levee, and to place riprap on the slope authorized under Permit No. 18323, 2009 - Meridian Farms Water Company). [Additional Reference(s): DWR Levee Log, 2007. USACE Sacramento O&M Manual 134, June 1953, (Station 889+72)].

View of waterward side.

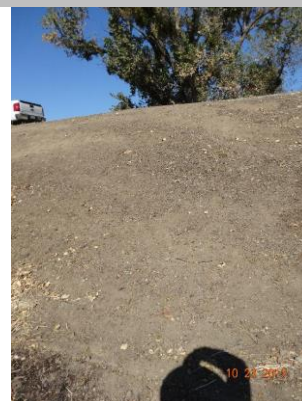
Photo 2 of 3 : UCIP_FA_2019_24197_42698.jpg

Item	DRAFT DWR UCIP Field Study			39.080517 °	39.080517 °	
				-121.890574 °	-121.890574 °	
DWR ID	21400					
Comment Code						
Inspector Comment						
DS_ID:21400 FS_ID:24197 EP_NO: 9986 Repair Type: Non-Urgent Crossing Status: Indicator Found UCIP Comments: Need to coordinate with owner to determine status of crossing. If crossing is no longer in use owner will need to contact the CVFPB to comply with Title 23. This crossing is referenced in the USACE Periodic Inspection as item USACE_CESPK_MRD2_2012_p_0527. FIELD_STRUCT_DESC: *ABANDONED* 30-inch steel irrigation discharge pipe through the levee, 27.5 feet below the crown. Two electric gate valves in a concrete pit on the waterside (WS) end, at the end of the discharge pipe. Two slant pumps on the WS slope. Control switches in a corrugated metal shed at the WS shoulder. (Plans for the installation of two inclined turbine pumps, a gate valve, a 50-horsepower pump, and an electrical conduit authorized under Permit No. 5193, 1965 - Meridian Farms Water Company. Retention of a 30-inch steel pipe through the levee, 27.5 feet below the crown, two gate valves, two slant pumps, and a metal building with switch panels authorized under Automatic Board Order (ABO) issued as Permit No. 9986, 1974 - Meridian Farms Water Company. Plans to abolish existing pumping plant and to abandon existing pipeline at RM 125.8 and to construct a new pumping plant at RM 127.0 consisting of two 30-inch intake pipes supported by seven 10-inch by 10-inch H beams, a fish screen, and a 36-inch pipe trenched through the levee, and to place riprap on the slope authorized under Permit No. 18323, 2009 - Meridian Farms Water Company). [Additional Reference(s): DWR Levee Log, 2007. USACE Sacramento O&M Manual 134, June 1953, (Station 889+72)]. FS Date: 10/23/2013

View of landward slope.

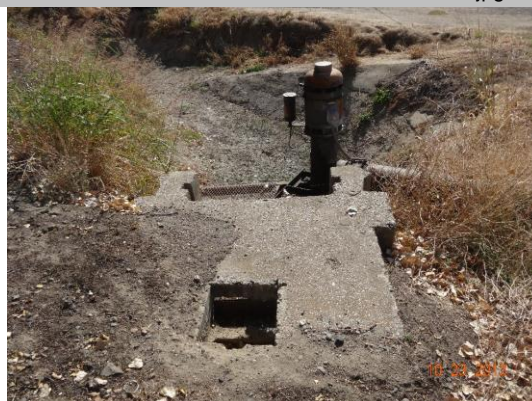
Photo 3 of 3 : UCIP_FA_2019_24197_42697.jpg

Item	DRAFT DWR UCIP Field Study			39.080517 °	39.080517 °	
				-121.890574 °	-121.890574 °	
DWR ID	21400					
Comment Code						
Inspector Comment						
DS_ID:21400 FS_ID:24197 EP_NO: 9986 Repair Type: Non-Urgent Crossing Status: Indicator Found UCIP Comments: Need to coordinate with owner to determine status of crossing. If crossing is no longer in use owner will need to contact the CVFPB to comply with Title 23. This crossing is referenced in the USACE Periodic Inspection as item USACE_CESPK_MRD2_2012_p_0527. FIELD_STRUCT_DESC: *ABANDONED* 30-inch steel irrigation discharge pipe through the levee, 27.5 feet below the crown. Two electric gate valves in a concrete pit on the waterside (WS) end, at the end of the discharge pipe. Two slant pumps on the WS slope. Control switches in a corrugated metal shed at the WS shoulder. (Plans for the installation of two inclined turbine pumps, a gate valve, a 50-horsepower pump, and an electrical conduit authorized under Permit No. 5193, 1965 - Meridian Farms Water Company. Retention of a 30-inch steel pipe through the levee, 27.5 feet below the crown, two gate valves, two slant pumps, and a metal building with switch panels authorized under Automatic Board Order (ABO) issued as Permit No. 9986, 1974 - Meridian Farms Water Company. Plans to abolish existing pumping plant and to abandon existing pipeline at RM 125.8 and to construct a new pumping plant at RM 127.0 consisting of two 30-inch intake pipes supported by seven 10-inch by 10-inch H beams, a fish screen, and a 36-inch pipe trenched through the levee, and to place riprap on the slope authorized under Permit No. 18323, 2009 - Meridian Farms Water Company). [Additional Reference(s): DWR Levee Log, 2007. USACE Sacramento O&M Manual 134, June 1953, (Station 889+72)]. FS Date: 10/23/2013

View of concrete slab with pump located on landward side.

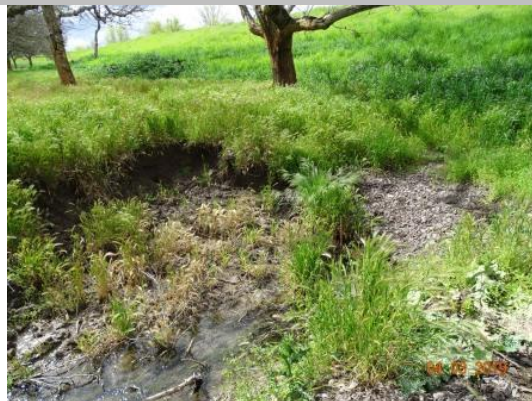
Photo 1 of 1 : FA_2019_RD0070_30_65_20190822_00011.jpg

LM Start	12.21	Rating **	A	Issue No.	65
LM End	12.21	Issue Type +	Ob	Location *	LS
Category	Earthen Levee		GPS Latitude/Longitude		
			Start	End	
Item	Seepage / Sandboils		39.074106 °	39.074106 °	
			-121.889696 °	-121.889696 °	
DWR ID	DWR_RD0070_02_s_2019_65				
Comment Code					
Inspector Comment					
RD placed a stake to mark the location of a boil. RD mentioned that the boil is within the ditch. Continue monitoring the boil during high water.

View of the ditch on the landside within the levee easement.

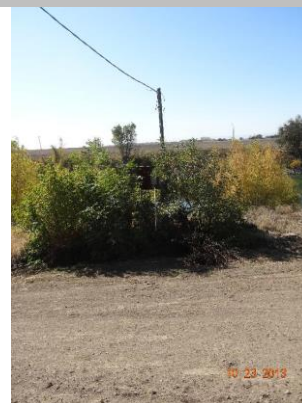
Photo 1 of 3 : UCIP_FA_2019_47033_42141.jpg

Comment Code						
Inspector Comment						
DS_ID:21402 FS_ID:47033 EP_NO: 9997 Repair Type: Non-Urgent Crossing Status: Found UCIP Comments: Debris found on waterward side along berm running parallel to levee. Two crossing found--Need to coordinate with owner to determine permit for second crossing and status of crossing. If crossing is no longer in use owner will need to contact the CVFPB to comply with Title 23. Dense vegetation limits the inspector's visibility to identify signs of pipe failure (leaks) along the waterward slope. Recommend removing vegetation along pipe alignment to conduct proper inspection of structure and appurtenances. This crossing is referenced in the USACE Periodic Inspection as item USACE_CESPK_MRD2_2012_p_0559. FIELD_STRUCT_DESC: 12-inch steel irrigation discharge pipe through the levee, 3.5 feet below the crown. Siphon breaker in a corrugated metal pipe (CMP) riser on the landside (LS) shoulder. Pump and control valve on the waterside (WS). Power pole on the WS shoulder. Discharge box at the LS toe. (Retention of a 12-inch steel pipe through the levee, 3.5 feet below the crown, a pump, a control valve, a siphon breaker, and a discharge box authorized under Automatic Board Order (ABO) issued as Permit No. 9997, 1974 - H. and Anne M. Rohleder). [Additional Reference(s): DWR Levee Log, 2007. USACE Sacramento O&M Manual 134, June 1953, (Station 930+22)]. FS Date: 10/23/2013

Crossing appurtenances located near brush and power pole on waterward side.

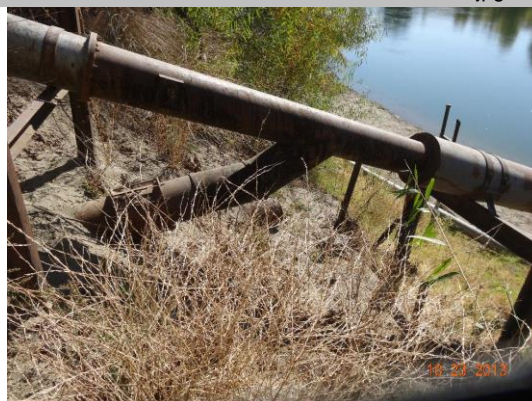
Photo 2 of 3 : UCIP_FA_2019_47033_42139.jpg

Pipe crossing on waterward side. Second pipe comes out approximately 3 feet downstream from this crossing.

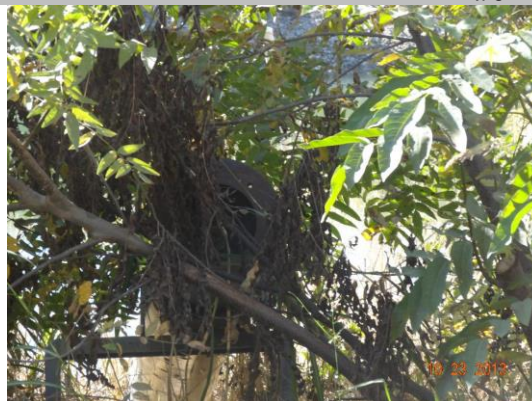
Photo 3 of 3 : UCIP_FA_2019_47033_42143.jpg

Pipe section exposed unable to determine if it is still in use.

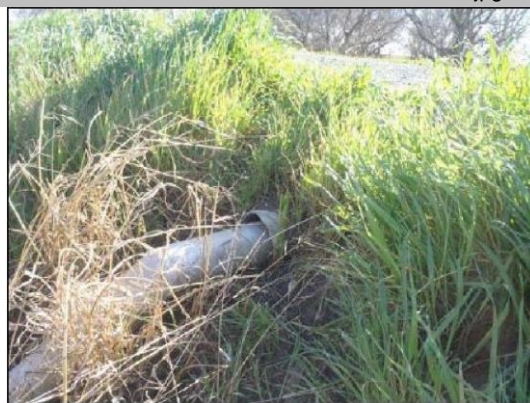
Photo 1 of 3 : UCIP_FA_2019_50086_42883.jpg

Comment Code					
Inspector Comment					
DS_ID:24744 FS_ID:50086 EP_NO: N/A Repair Type: Non-Urgent Crossing Status: Found UCIP Comments: 07/07/2016 Dense vegetation on both slopes. No damage was observed on levee slopes or crown, crossing was downgraded from Urgent to Non-Urgent. No permit found for crossing. Need to recheck during winter. According to Andy Duffey, District Representative, CVFPB has issued a enforcement letter to owner dated 6/23/2016. (DWR UCIP - omagana)10/23/2013 No records were found during initial desk study--need to contact owner to obtain permit number authorizing work. Owner will need to coordinate with DWR Inspector and CVFPB to remove crossing according to Title 23 requirements. (DWR UCIP - omagana) FIELD_STRUCT_DESC: 6-inch aluminum irrigation pipe sleeved through a 10-inch corrugated metal pipe through the levee, 1.5 feet below the crown. Annular space not grouted. Pipe extends down both slopes about 2 feet below the crown. FS Date: 7/7/2016 10:39:00 AM

View of pipe through levee--photo is from USACE PI Draft Report dated 6-2012.

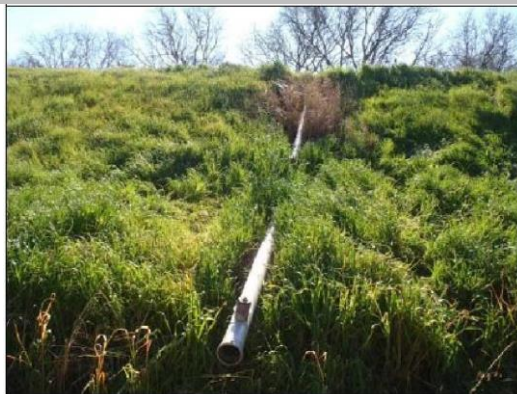
Photo 2 of 3 : UCIP_FA_2019_50086_42882.jpg

View of pipe through levee--photo is from USACE PI Draft Report dated 6-2012.

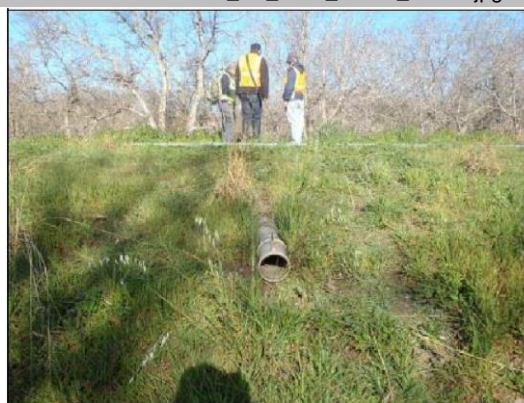
Photo 3 of 3 : UCIP_FA_2019_50086_42881.jpg

View of pipe through levee--photo is from USACE PI Draft Report dated 6-2012.

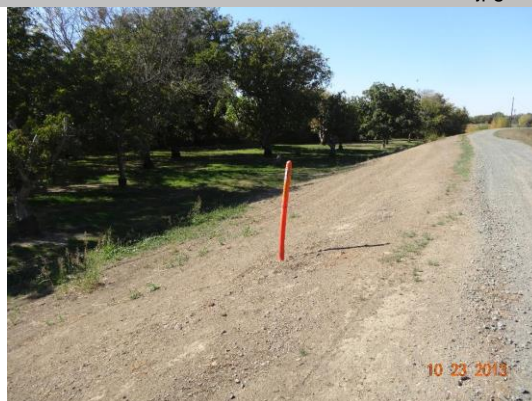
Photo 1 of 3 : UCIP_FA_2019_23984_42172.jpg

Comment Code					
Inspector Comment					
DS_ID:21403 FS_ID:23984 EP_NO: 3800 Repair Type: Non-Urgent Crossing Status: Indicator Found UCIP Comments: Need to contact owner to determine if crossing is still active and to determine last inspection date. Will need copy of letter showing crossings passed inspection. This crossing is referenced in the USACE Periodic Inspection as item USACE_CESPK_MRD2_2012_p_0568. FIELD_STRUCT_DESC: 20-inch coated steel natural gas pipeline through the levee, 3 feet below the crown. Concrete cutoff wall around the pipe at the center of the levee. Marker sign on the waterside (WS) shoulder. Natural gas equipment pad at the landside (LS) toe. (Plans to construct and maintain a 20-inch gas line across the Sacramento River authorized under Permit No. 3800, 1961 - Pacific Gas and Electric Company [PG&E]). [Additional Reference(s): DWR Levee Log, 2007]. FS Date: 10/23/2013

Marker located on waterward side.

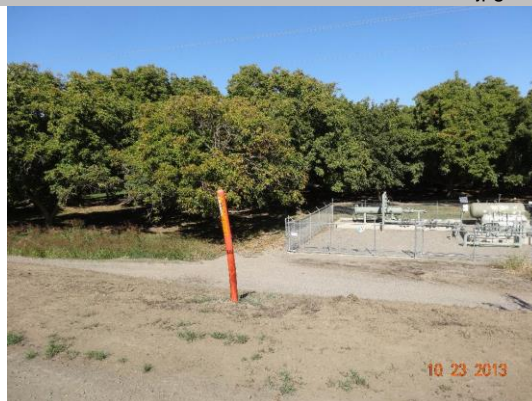
Photo 2 of 3 : UCIP_FA_2019_23984_42171.jpg

Marker on landward side.

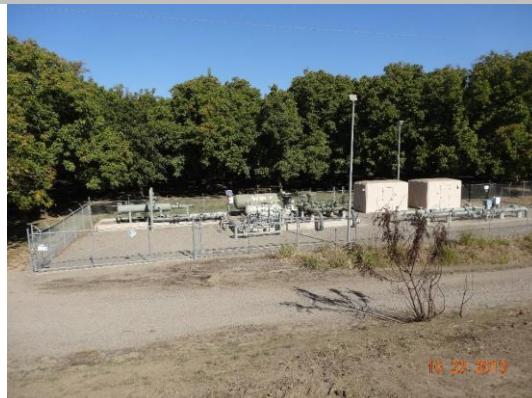
Photo 3 of 3 : UCIP_FA_2019_23984_42170.jpg

Additional appurtenances located on landward side.

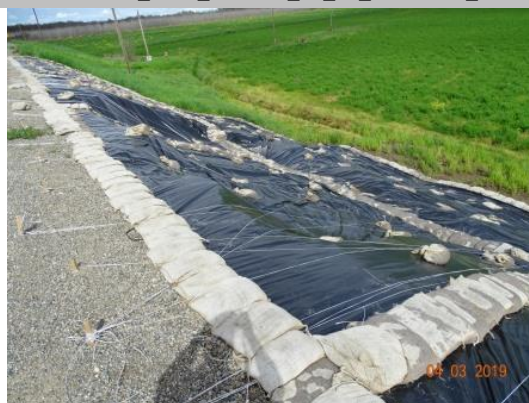
Photo 2 of 2 : FA_2019_RD0070_30_66_20190822_00013.jpg

LM Start	12.93	Rating **	U	Issue No.	66
LM End	13.03	Issue Type +	Ma	Location *	LS
Category	Earthen Levee			GPS Latitude/Longitude	
				Start	End
Item	Slope Stability			39.071323°	39.070900°
				-121.877606°	-121.875728°
DWR ID	DWR_RD0070_02_s_2019_66				
Comment Code					
S1 : Repair slope instability.					
Inspector Comment					
Sloughing on the landside slope occurred during the February 2019 storms. A temporary solution was used to address the issue. Permanent repairs should be completed to stabilize the slope.

View of the temporary solution used to address the sloughing. April 3, 2019.

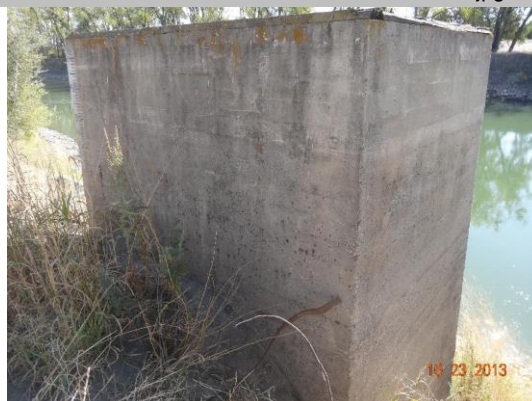
Photo 1 of 1 : UCIP_FA_2019_47039_42800.jpg

Comment Code						
Inspector Comment						
DS_ID:21407 FS_ID:47039 EP_NO: 9995 Repair Type: Non-Urgent Crossing Status: Indicator Found UCIP Comments: Records show a 24-inch iron pipe through the waterward side along the old gaging station with the concrete struture located on the waterward slope. FIELD_STRUCT_DESC: [Reclamation District No. 70 (RD0070) Drainage Plant] 1 of 5: 30-inch steel drainage discharge pipe through the levee at low elevation. Pipe is concrete encased under the crown, between the shoulders. Slide gate on the landside (LS). Flap gate in a secured structure on the waterside (WS) end. (Retention of a 30-inch steel drainage pipe through the levee, at low elevation, a slide gate, and a flap gate authorized under Automatic Board Order (ABO) issued as Permit No. 9995, 1974 - RD0070. Plans to construct a 10-foot by 12-foot by 19-foot concrete outlet structure on existing outlet pipes, to repair leaking pipes, to repair existing pumping plant, and to install sheet piling at the inlet ditch to allow continued operation of the pumping plant by the district authorized under Permit No. 13420, 1982 - RD0070). [Additional Reference(s): DWR Levee Log, 2007. USACE Sacramento O&M Manual 134, June 1953, (Station 1007+10), referenced pipes at this location are 48 inches, 40 inches, and 50 inches]. FS Date: 10/23/2013

Remains of old gaging station associated with 24-inch iron pipe that extends into the river.

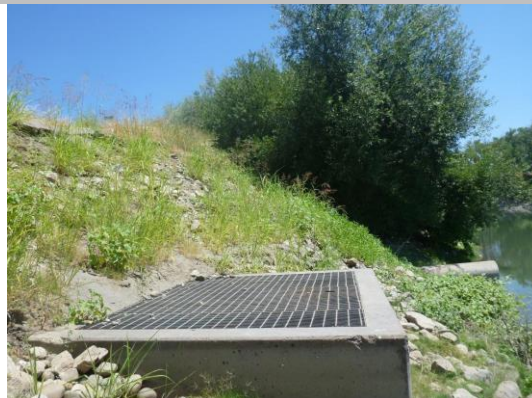
Photo 3 of 3 : LEVAL_FA_2019_152_1730.jpg

LM Start	13.83	Rating **	A/W	Issue No.	75 (cont)	
LM End	13.83	Issue Type +	Ma	Location *		
Category	Supplemental			GPS Latitude/Longitude		
				Start	End	
Item	2017 Storm Damage			39.068190°	39.068190°	
				-121.862700°	-121.862700°	
DWR ID	RD 70-01					
Comment Code						
Inspector Comment						
Levee Evaluation Comments						
Description:						
Site ID No:152						
Site Designation:RD 70-01						
Repair Type: Erosion						
Rating:Area of Concern						
Field Date:7/17/2017						
Notes: bank slope erosion around a drainage pipe/box

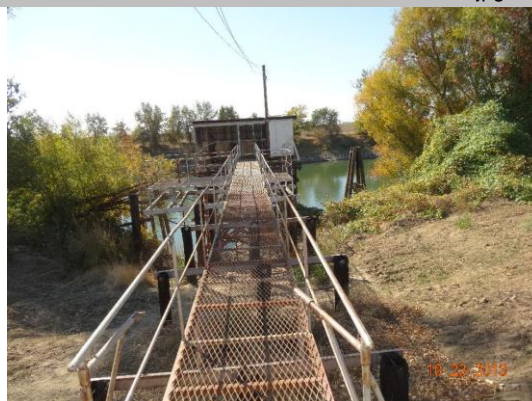
Photo 1 of 3 : UCIP_FA_2019_24229_42848.jpg

Comment Code						
Inspector Comment						
DS_ID:21421 FS_ID:24229 EP_NO: 9990 Repair Type: Non-Urgent Crossing Status: Found UCIP Comments: Need to determine if crossings are still being used. This crossing is referenced in the USACE Periodic Inspection as item USACE_CESPK_MRD2_2012_p_0685. FIELD_STRUCT_DESC: 1 of 2: 24-inch steel irrigation discharge pipe sleeved through a 30-inch coated steel pipe through the levee, 24 feet below the crown. Gate valve on the waterside (WS) end. Concrete headwall with a flap gate on the landside (LS). Pump on a pile structure in the stream. Wooden walkway to the pump. (Retention of two 24-inch steel pipes through the levee, 24 feet below the crown, two pumps, and two gate valves authorized under Automatic Board Order (ABO) issued as Permit No. 9990, 1974 - Newhall Land and Farming Company). [Additional Reference(s): DWR Levee Log, 2007. USACE Sacramento O&M Manual 134, June 1953, (Station 1086+55)]. FS Date: 10/23/2013

Walkway and pump house on waterward side.

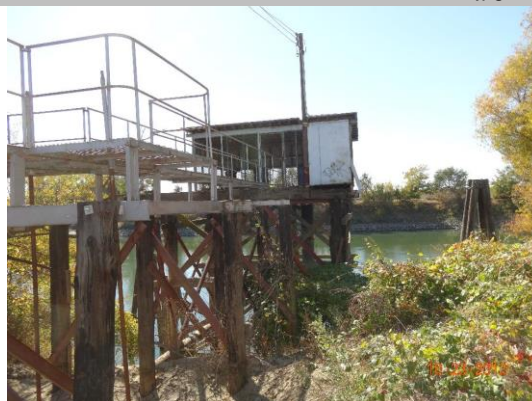
Photo 2 of 3 : UCIP_FA_2019_24229_42849.jpg

Pump house located on waterward side.

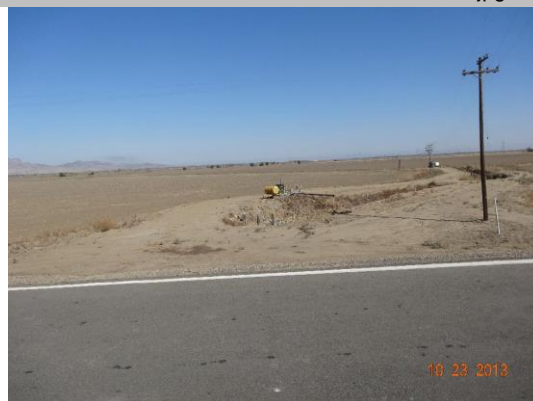
Photo 3 of 3 : UCIP_FA_2019_24229_42853.jpg

Overview of landward side.

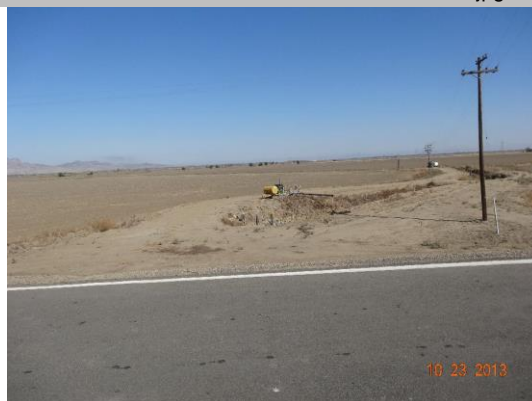
Photo 3 of 3 : UCIP_FA_2019_24230_42858.jpg

Item	DRAFT DWR UCIP Field Study			39.065294 °	39.065294 °	
				-121.839215 °	-121.839215 °	
DWR ID	21409					
Comment Code						
Inspector Comment						
DS_ID:21409 FS_ID:24230 EP_NO: 9990 Repair Type: Non-Urgent Crossing Status: Found UCIP Comments: Need to determine if crossing is still being used. This crossing is referenced in the USACE Periodic Inspection as item USACE_CESPK_MRD2_2012_p_0685. FIELD_STRUCT_DESC: 2 of 2: 24-inch steel irrigation discharge pipe sleeved through a 30-inch coated steel pipe through the levee, 24 feet below the crown. Gate valve on the waterside (WS) end. Concrete headwall with a flap gate on the landside (LS). Pump on a pile structure in the stream. Wooden walkway to the pump. (Retention of two 24-inch steel pipes through the levee, 24 feet below the crown, two pumps, and two gate valves authorized under Automatic Board Order (ABO) issued as Permit No. 9990, 1974 - Newhall Land and Farming Company). [Additional Reference(s): DWR Levee Log, 2007. USACE Sacramento O&M Manual 134, June 1953, (Station 1086+55)]. FS Date: 10/23/2013

Overview of landward side.

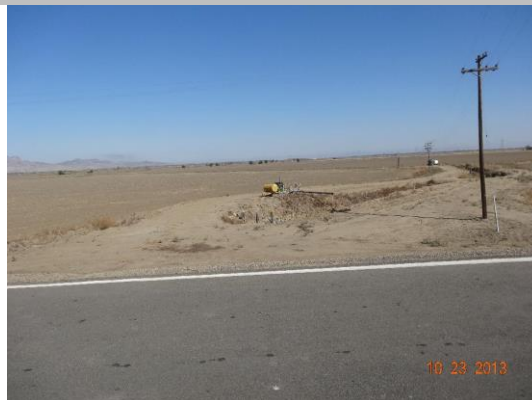
Photo 2 of 3 : UCIP_FA_2019_24231_42863.jpg

Comment Code						
Inspector Comment						
DS_ID:21420 FS_ID:24231 EP_NO: N/A Repair Type: Non-Urgent Crossing Status: Found UCIP Comments: No daylight visible on landward side. Pipe was visible on waterward side. Need to contact owner to determine status of crossing. This crossing is referenced in the USACE Periodic Inspection as item USACE_CESPK_MRD2_2012_p_0685. FIELD_STRUCT_DESC: 16-inch steel irrigation discharge pipe through the levee, approximately 15 feet below the crown. Gate valves on the waterside (WS) end. Pumps on the WS. [Additional Reference(s): USACE Sacramento O&M Manual 134, June 1953, (Station 1086+55)]. FS Date: 10/23/2013

View of landward side.

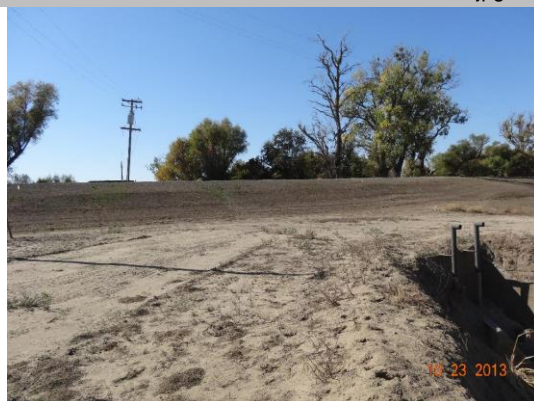
Photo 3 of 3 : UCIP_FA_2019_24231_42860.jpg

View of landward side photo taken from concrete headwall.
